LMX9830 Bluetooth Serial Port Module Firmware Release Notes

Texas Instruments
Firmware Release Notes
January 2007
Revised February 2013
Revision 1.4

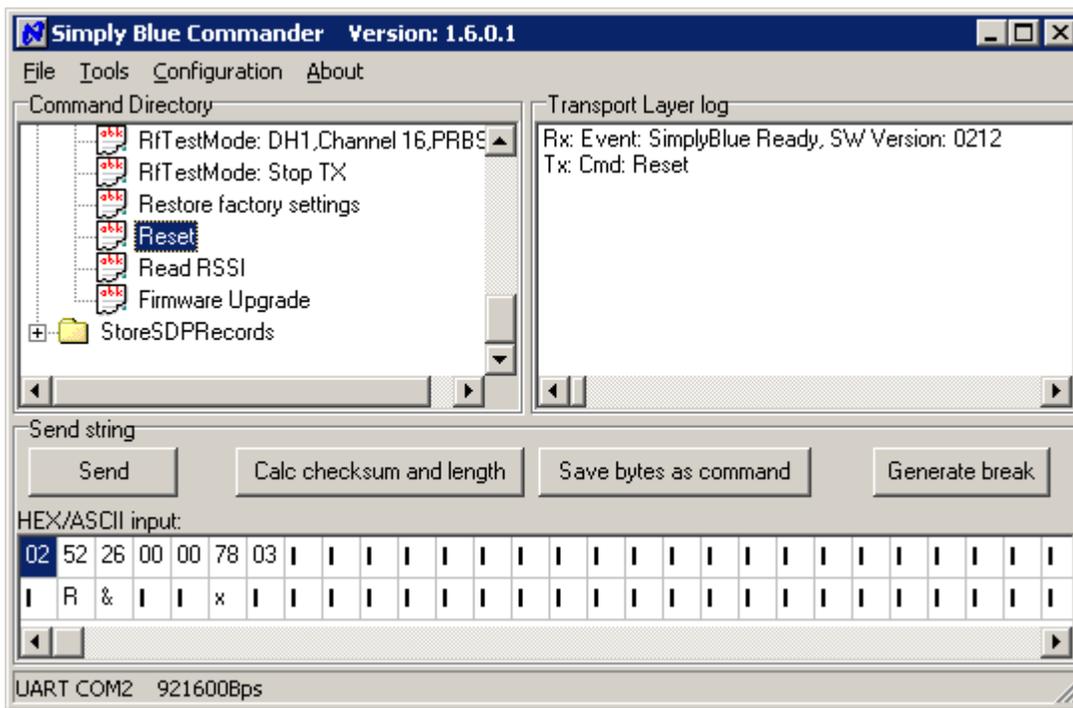
Figure 1-1. “SimplyBlue Ready” in Simply Blue Commander

Each LMX9830 comes up with a certain “Ready” Event, which indicates the completed boot process of the device. This event also includes the firmware version of the device. The “Ready” appears after boot or after a software reset.

See Figure 1-1 for a screenshot of the event in Simply Blue Commander.

For example, the LMX9830 will come up with the hexadecimal code

Rx(RAW): 02,69,25,05,00,93,04,**30,32,31,32**,03

on which the bold bytes indicate the firmware version (in this case 0212).

In order to avoid any future upgrade problems, please make sure your software does not use this parameter as part of the decision to continue. The parameter should just be used for informational purposes.

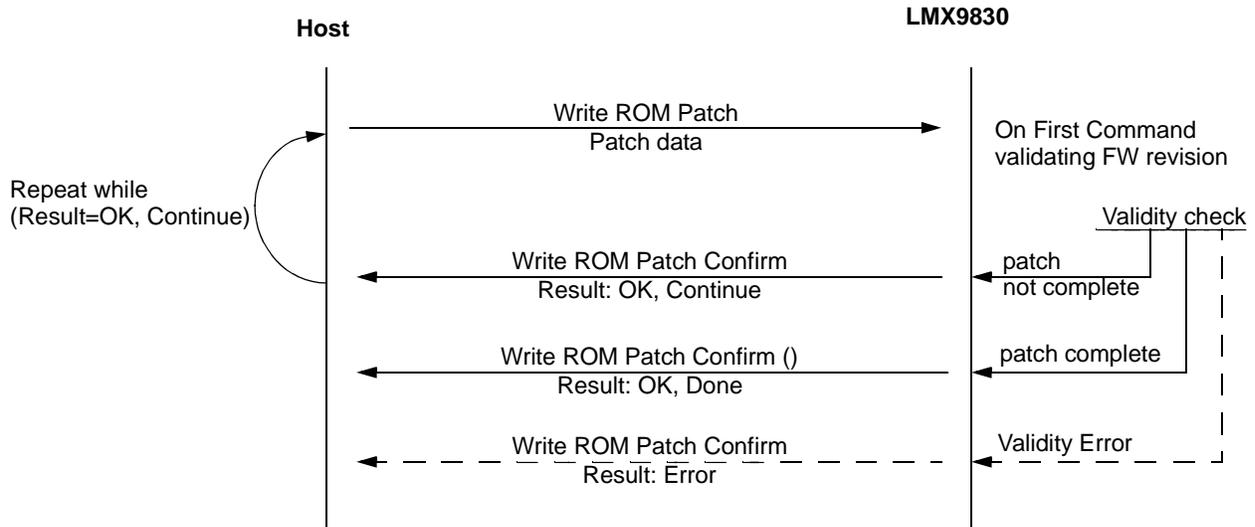
Figure 1-2. Write ROM patch flow

In case no EEPROM is connected, patches need to be supplied via the command interface using the “Write ROM patch” command. Since patches usually require more than one command, the patching requires a specific command flow to be

followed. See Figure 1-2 for the general patch flow. The complete process is also described in the “LMX9830 Software Users Guide”.

The Write ROM patch mechanism includes a validity check of the ROM pushed to the device. In case, no error is found the error code is either 0x01 for continue or 0x00 for OK, Done.

In case the error code is different to those two, some error must have occurred. The following error codes are defined

So in case the host tries to apply a patch released for firmware 2.10, to a 2.12 device, the confirm will respond with error message 0x84.

Therefore the software needs to be prepared to handle this error code correctly by either continuing with the normal boot process without the patch, or to try to apply a patch for another firmware version.

To be prepared for future upgrades, the host application should not stop the execution due to this error code.
